### EXPERIMENTAL AUXILIARY ROCKET ENGINE

CONTRACT NAS 7-305

FINAL REPORT

REPORT NO. 8374-933004

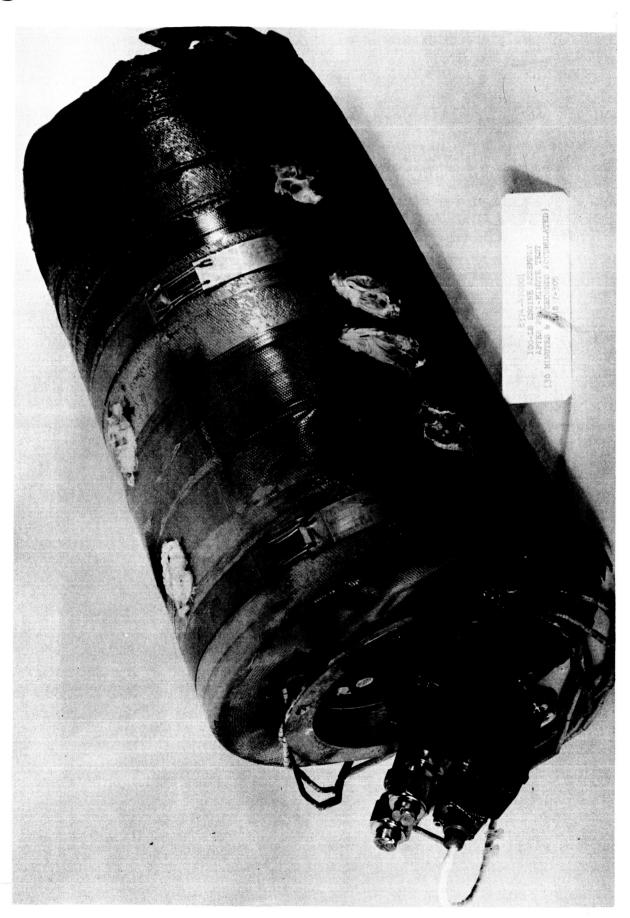
Post-run inspection of the engine assembly disclosed a burnout in the chamber section at approximately the 1:00 o'clock position. The burnout was approximately one inch in diameter and two inches from the injector. The burnout caused damage to the alumina bubble insulation, the columbium shell, the "Dyna-Quartz" insulation, and the fiberglass wrap at the injector end of the assembly. Another small burnout region about 1/8 inch in diameter was noted in the chamber section at approximately the 3:00 o'clock position. No damage had occurred to the insulation material in this area of the chamber. Metal was deposited at the throat station apparently accounting for at least a portion of the chamber pressure increase noted during the last two tests.

Figure VI-47. Chamber Burnout Region - Engine Assembly S/N 2 After Fire Test

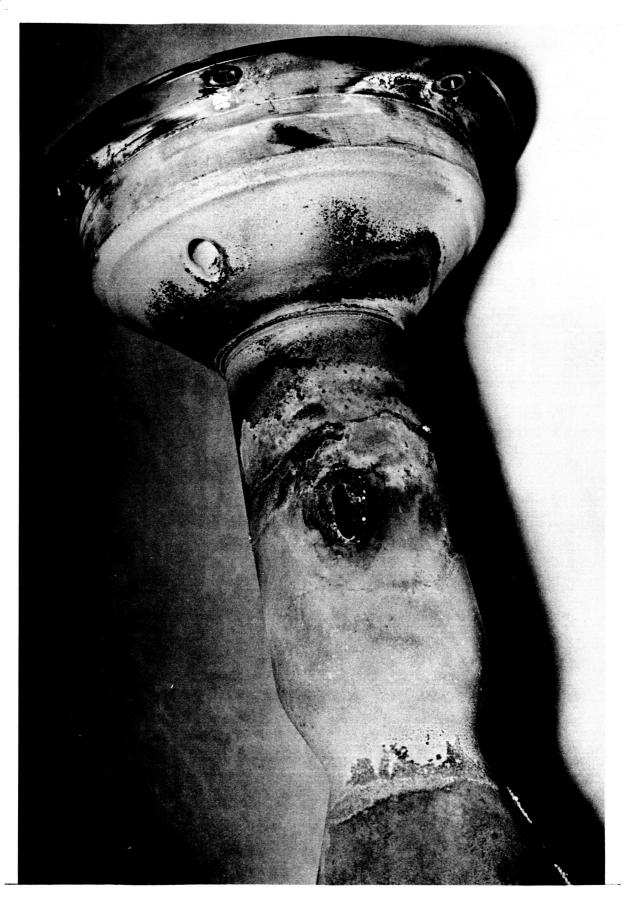
- (1) Severe nozzle damage had occurred.
- (2) Slight throat erosion was evident at the 12:30 and 6:00 o'clock positions with chamber wall erosion and burnout noted at 12:30 o'clock position. The burnout was about two inches from the injector face and was approximately 1/2 inch wide and 3/16 inch long. The erosion pattern was approximately one inch wide and two and one-half inches long. A black discoloration was observed on the fiberglass wrap directly "over" the burnout and was approximately one inch in diameter.
